# **EVENT DIAL PACK** SYMPOSIUM REPORT (U) **VOLUME III**

November 1971

**DNA 2722T**

EVENT DIAL PACK SYMPOSIUM REPORT (U)

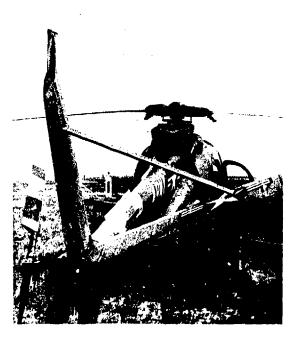
Figure 10 (U) Damaged tail boom fins on the OH-6(1) helicopter (U).

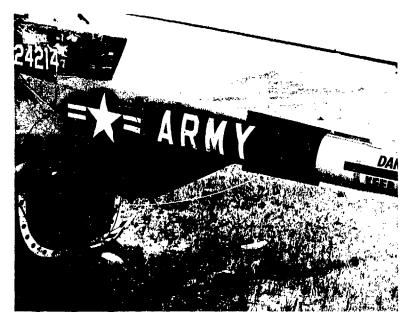
Figure 11 (U) Damaged tail boom—fuselage joint on the OH-6(1) helicopter (U).

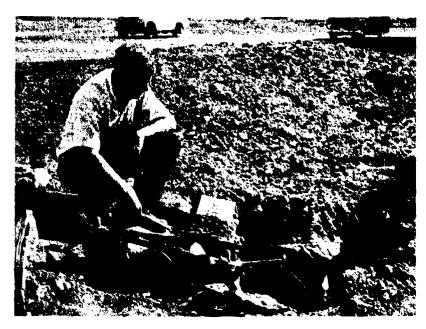
Figure 3.2 (C) Postshot view of entrance damage, shelter 1 (U).

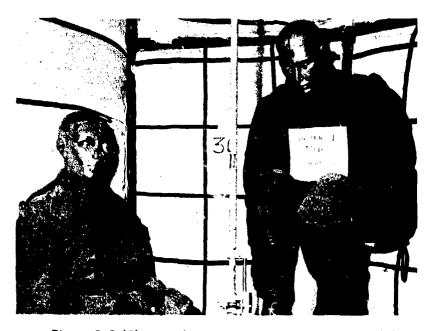
Figure 3.3 (C) Postshot view of dummies, shelter 1 (U).
